# Inspection Report

**Property Address:**  
153 SW 40th St  
Oak Island NC 28465

**CB Carter Home Inspections**

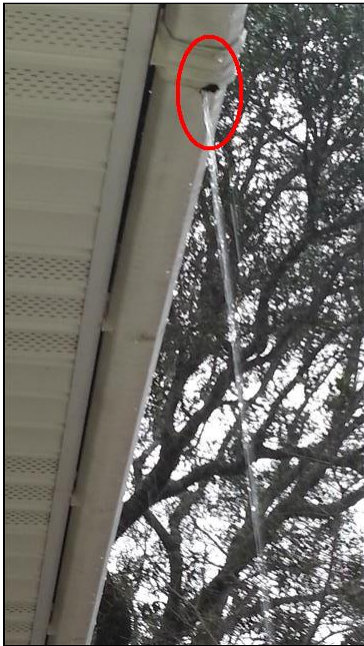
**1.3** There is a hole in bottom of gutter over garage door at front of house that was leaking at time of inspection. All of the downspouts around house are loose and not properly attached to house or have broken clips. There is only one downspout at gutter at top of rear of house. This is not adequate to handle the amount of rain water there was at time of inspection and gutter overflowed to lower roof over kitchen. This could possibly allow water penetration around the windows at master bedroom or at kitchen roof where it attaches to house. Recommend further evaluation and repairs by a qualified professional.

1.3 Item 1(Picture) Gutter over garage door

There is a hole in bottom of gutter over garage door at front of house that was leaking at time of inspection. All of the downspouts around house are loose and not properly attached to house or have broken clips. There is only one downspout at gutter at top of rear of house. This is not adequate to handle the amount of rain water there was at time of inspection and gutter overflowed to lower roof over kitchen. This could possibly allow water penetration around the windows at master bedroom or at kitchen roof where it attaches to house. Recommend further evaluation and repairs by a qualified professional.

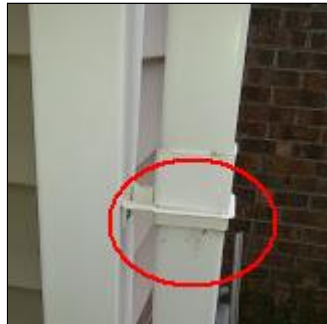
1.3 Item 2(Picture) Front left downspout

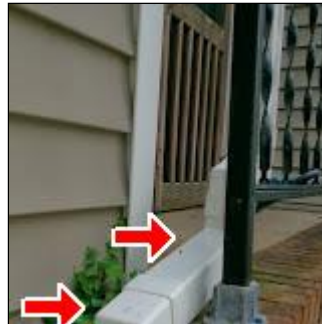
1.3 Item 3(Picture) Downspout at front porch

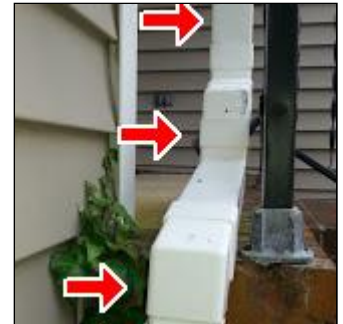
1.3 Item 4(Picture) Downspout at front porch

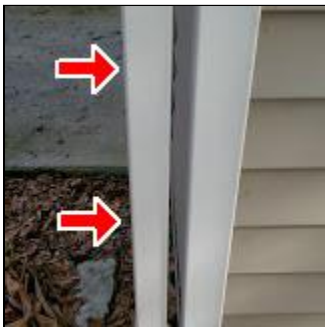
1.3 Item 5(Picture) Downspout at right of garage

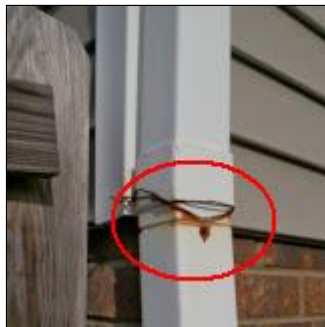
1.3 Item 6(Picture) Right rear corner downspout

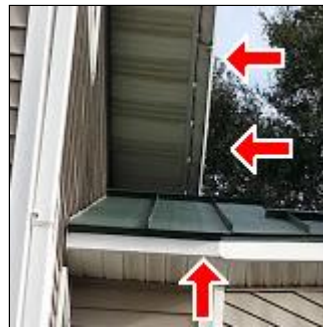
1.3 Item 7(Picture) Roof over kitchen

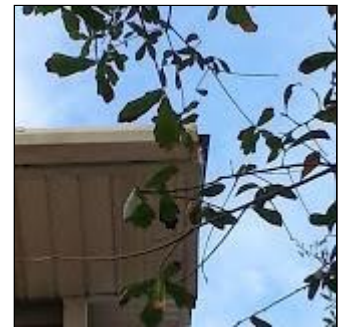
1.3 Item 8(Picture) Left rear gutter

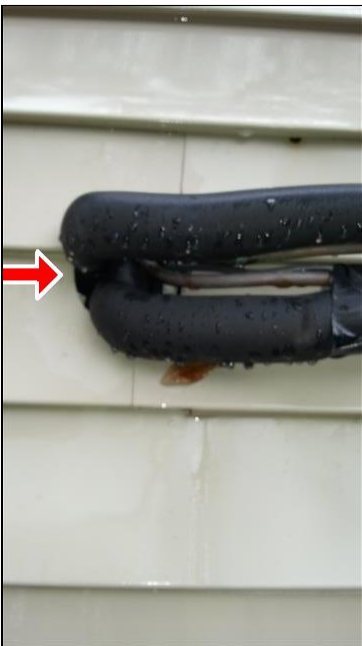
**2.0** There is opening around refrigerant line from heat pump as it enters side of house at garage that could allow varmints to enter house. Recommend further evaluation and repairs by a qualified professional.

2.0 Item 1(Picture) Side of garage

There is opening around refrigerant line from heat pump as it enters side of house at garage that could allow varmints to enter house. Recommend further evaluation and repairs by a qualified professional.

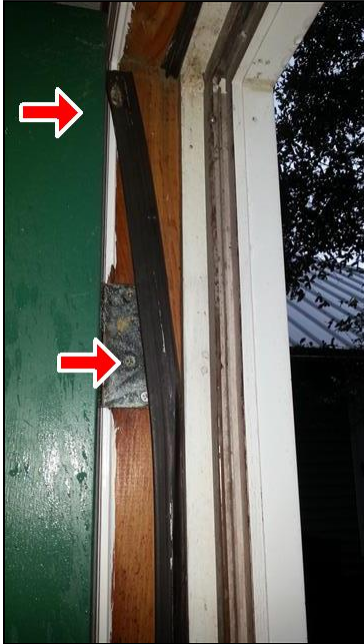
**2.1** Weather stripping at front entry and rear french doors are frayed and coming loose. Recommend further evaluation and repairs.

2.1 Item 1(Picture) Rear french door

Weather stripping at front entry and rear french doors are frayed and coming loose. Recommend further evaluation and repairs.

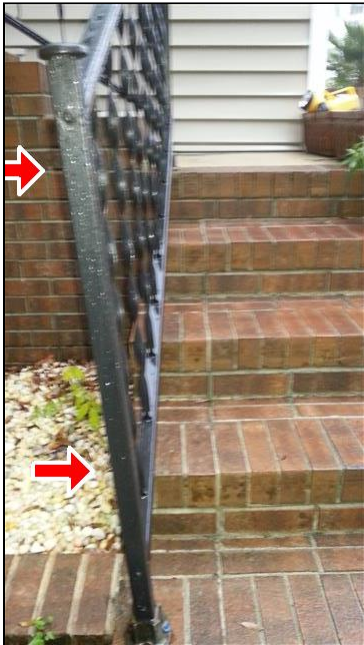
**2.3** The metal railings at front porch are loose and could be a potential safety issue as they don't allow for proper support. The bottom step at rear deck stairs is uneven and could be a potential trip hazard. The brick border at patio is separated from patio and could be a potential trip hazard. Recommend further evaluation and repairs by a qualified professional.

2.3 Item 1(Picture) Front porch railing

The metal railings at front porch are loose and could be a potential safety issue as they don't allow for proper support. The bottom step at rear deck stairs is uneven and could be a potential trip hazard. The brick border at patio is separated from patio and could be a potential trip hazard. Recommend further evaluation and repairs by a qualified professional.

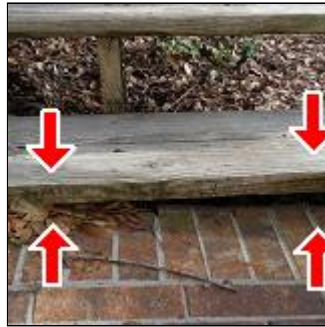
2.3 Item 2(Picture) Deck stairs

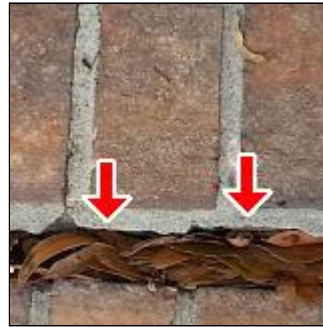
2.3 Item 3(Picture) Patio stairs

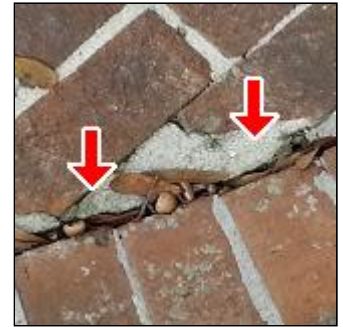
2.3 Item 4(Picture) Patio stairs

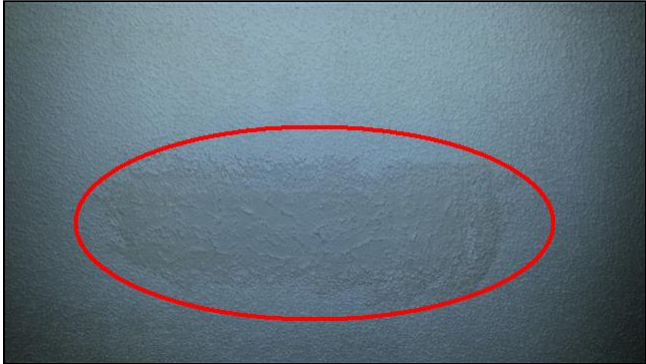
**4.0** There is repair of sheetrock at ceiling in left upstairs bedroom. There are no signs of active leakage. Area was below ridge vent and could have been caused by heavy wind and rain. Recommend monitoring this area for future leakage.

4.0 Item 1(Picture) Left upstairs bedroom

There is repair of sheetrock at ceiling in left upstairs bedroom. There are no signs of active leakage. Area was below ridge vent and could have been caused by heavy wind and rain. Recommend monitoring this area for future leakage.

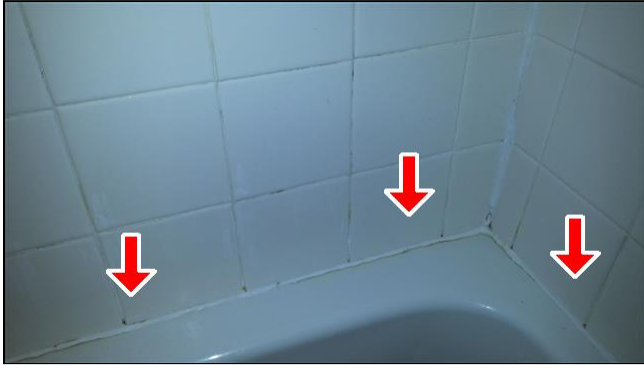
**4.1** The tile around tub in master bath and upstairs bath are in need of caulk or grout at base of wall at tub. Recommend further evaluation and repairs

4.1 Item 1(Picture) Master bath

The tile around tub in master bath and upstairs bath are in need of caulk or grout at base of wall at tub. Recommend further evaluation and repairs

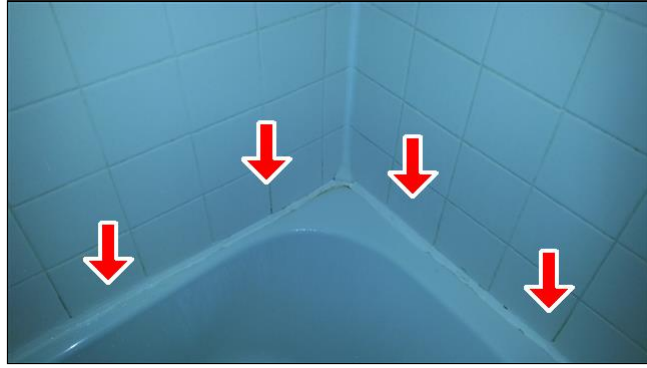
4.1 Item 2(Picture) Upstairs bath

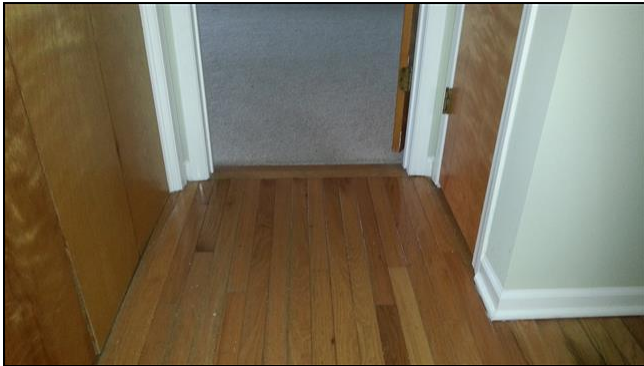
**4.2** The floor in front of washer/dryer has water stains. This could be from leakage or overflow from washer. A pan under washer could reduce possibility of damage to hardwood floors.

4.2 Item 1(Picture) Floor in front of washer/dryer

The floor in front of washer/dryer has water stains. This could be from leakage or overflow from washer. A pan under washer could reduce possibility of damage to hardwood floors.

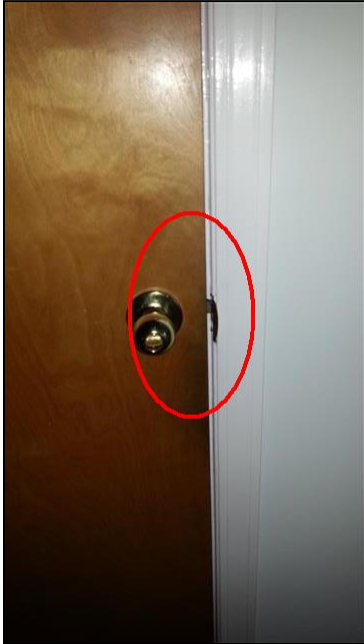
**4.5** The master bedroom and upstairs right bedroom doors have gap at latch side of door and don't latch or lock properly. Recommend further evaluation and repairs.

4.5 Item 1(Picture) Master bedroom

The master bedroom and upstairs right bedroom doors have gap at latch side of door and don't latch or lock properly. Recommend further evaluation and repairs.

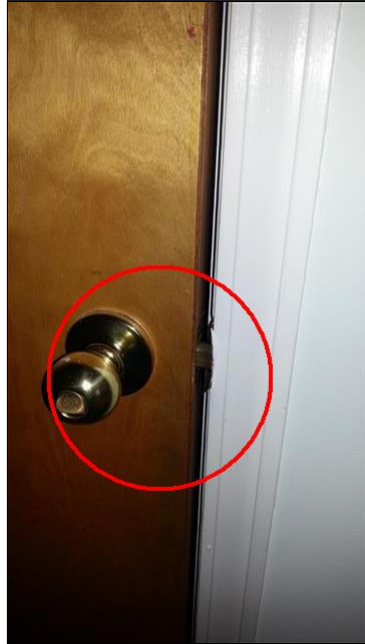
4.5 Item 2(Picture) Upstairs right bedroom

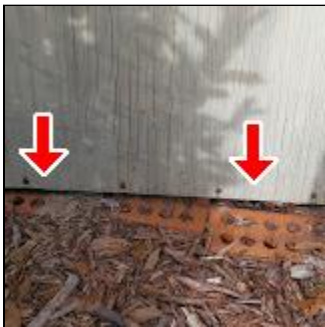
**5.0** There are loose bricks at base of crawlspace door that could allow varmints to enter crawlspace. Recommend further evaluation and repairs.

5.0 Item 1(Picture)  
Crawlspace access door

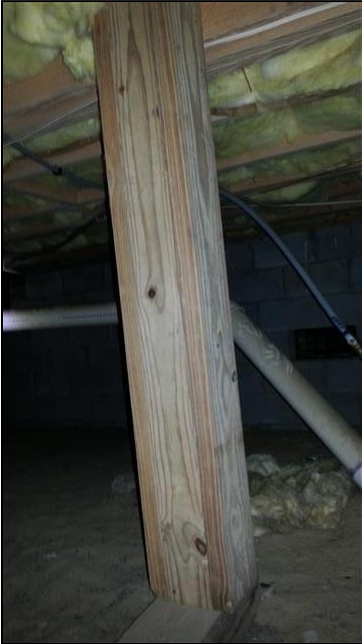
**5.2** There was post added in crawlspace under post at bottom of stair railing as you enter house. There are know signs of any sag or settlement but would recommend monitoring this area for any possible future settling.

5.2 Item 1(Picture) Post in crawlspace

There was post added in crawlspace under post at bottom of stair railing as you enter house. There are no signs of any sag or settlement but would recommend monitoring this area for any possible future settling.

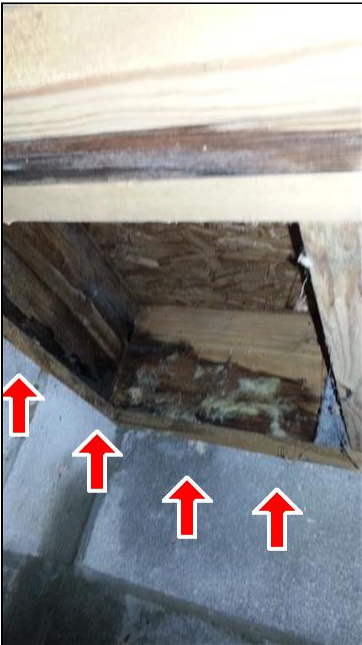
**5.3** There were signs of water stain and penetration at sub floor and outside band below entry door. There was flashing and caulk around top edge of front porch concrete slab. There was no signs of active water penetration at this area but would recommend monitoring this area for future water penetration.

5.3 Item 1(Picture) Floor and band

There were signs of water stain and penetration at sub floor and outside band below entry door. There was flashing and caulk around top edge of front porch concrete slab. There were no signs of active water penetration at this area but would recommend monitoring this area for future water penetration.

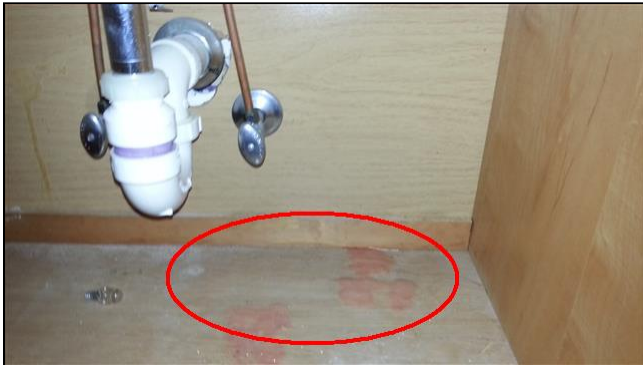
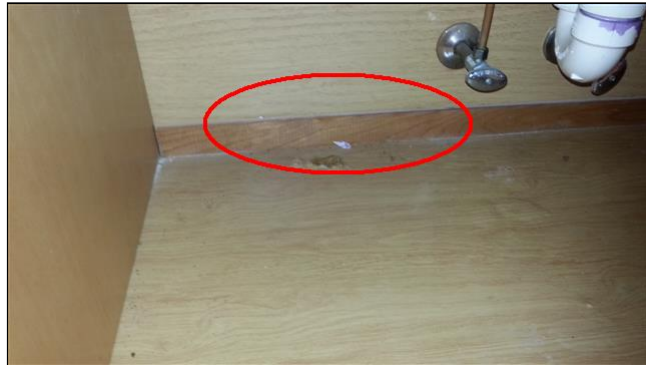
**6.0** Main water shutoff is under house as water line enters crawlspace at front porch. The only water shutoff that could be located outside of house was at water meter at street. Most of the sink cabinets in bathrooms and kitchen had water stains from past leaks. There were no signs of active leaks other than bad seals in faucets but would recommend monitoring. The toilet in half bath was loose at base and needs to be secured with a new seal. Recommend further evaluation and repairs by a qualified professional.

6.0 Item 1(Picture) Cabinet base

6.0 Item 2(Picture) Cabinet base

Main water shutoff is under house as water line enters crawlspace at front porch. The only water shutoff that could be located outside of house was at water meter at street. Most of the sink cabinets in bathrooms and kitchen had water stains from past leaks. There were no signs of active leaks other than bad seals in faucets but would recommend monitoring. The toilet in half bath was loose at base and needs to be secured with a new seal. Recommend further evaluation and repairs by a qualified professional.

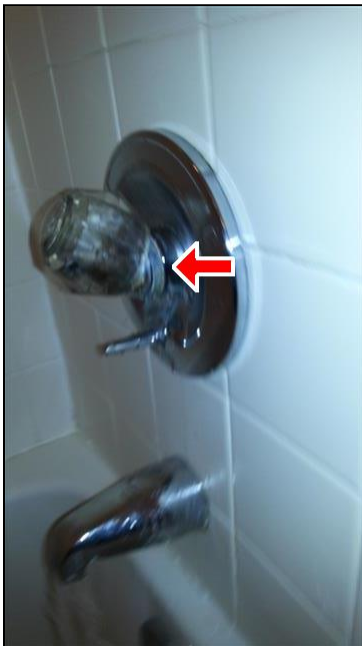
**6.1** (1) The 1/2 bath faucet, right master bath sink faucet, tub faucet and both upstairs sink faucets have bad seals and leak at handles. Recommend further evaluation and repairs by a qualified professional. There were supply lines identified in crawlspace that are polybutylene. Polybutylene plastic plumbing supply lines (PB) are installed in the subject house. Polybutylene has been used in this area for many years, but has had a higher than normal failure rate, and is no longer being widely used. Copper and Brass fittings used in later years have apparently reduced the failure rate. This subject house has Copper and Brass fittings. For further details contact the Consumer Plumbing Recovery center at 1-800-392-7591 or the web at <http://www.pbpipe.com>

6.1 Item 1(Picture) Faucet handle

(1) The 1/2 bath faucet, right master bath sink faucet, tub faucet and both upstairs sink faucets have bad seals and leak at handles. Recommend further evaluation and repairs by a qualified professional. There were supply lines identified in crawlspace that are polybutylene. Polybutylene plastic plumbing supply lines (PB) are installed in the subject house. Polybutylene has been used in this area for many years, but has had a higher than normal failure rate, and is no longer being widely used. Copper and Brass fittings used in later years have apparently reduced the failure rate. This subject house has Copper and Brass fittings. For further details contact the Consumer Plumbing Recovery center at 1-800-392-7591 or the web at <http://www.pbpipe.com>

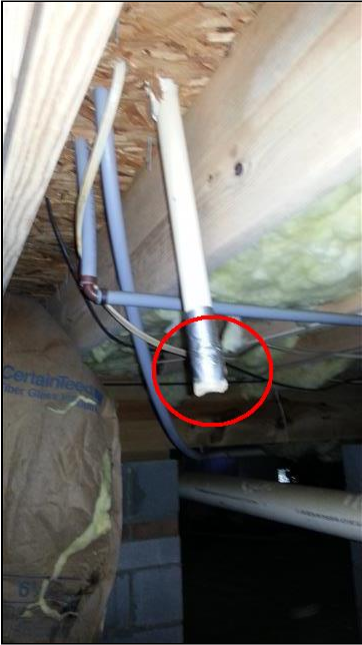
**6.2** The hot water heater pan drain line has tape over end of pipe so drain pan can't drain properly if needed. Drain line should also drain to outside of house and not in crawlspace. Recommend further evaluation and repairs by a qualified professional.

6.2 Item 1(Picture) Hot water heater pan drain

The hot water heater pan drain line has tape over end of pipe so drain pan can't drain properly if needed. Drain line should also drain to outside of house and not in crawlspace. Recommend further evaluation and repairs by a qualified a professional.

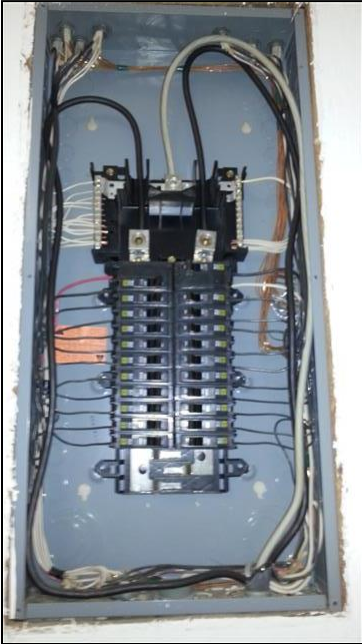
**7.2** There are over six breakers in panel in garage without a main shutoff. This could be a potential safety issue. Recommend further evaluation and repairs by a qualified professional.

7.2 Item 1(Picture) Electrical panel in garage

There are over six breakers in panel in garage without a main shutoff. This could be a potential safety issue. Recommend further evaluation and repairs by a qualified professional.

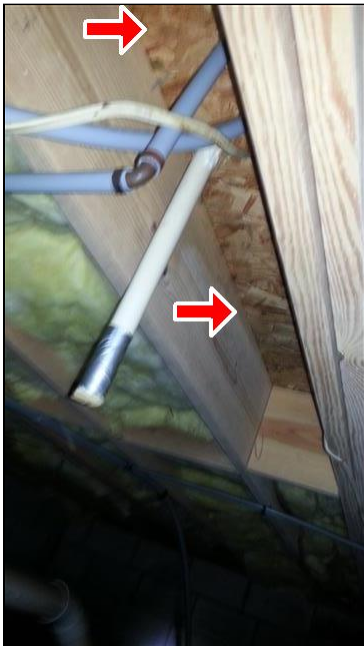
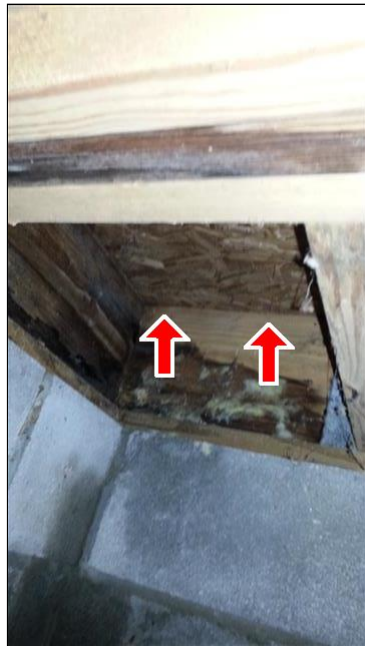
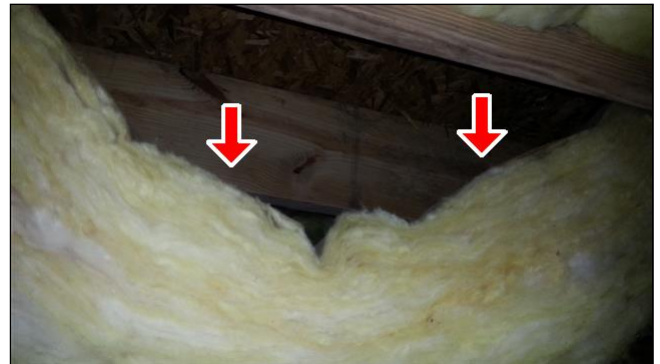
**9.1** There are several areas in crawlspace at sub floor that has missing or loose insulation. Recommend further evaluation and repair.

9.1 Item 1(Picture) Sub floor

9.1 Item 2(Picture) Sub floor

9.1 Item 3(Picture) Loose insulation

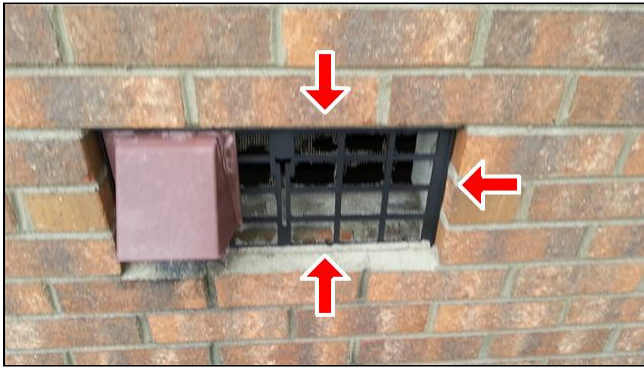
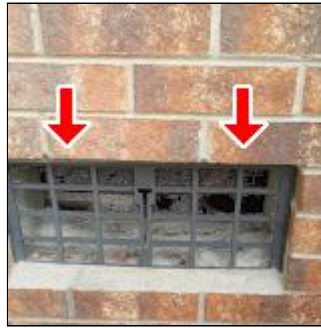
**9.3** There are five foundation vents that are missing screen or have holes in vent screen (1 at rear, 3 on right side and 1 in garage). There are no vent covers to close vents in winter months at foundation vents. Recommend further evaluation and repairs.

9.3 Item 1(Picture) Foundation vent

9.3 Item 2(Picture)  
Foundation vent
